Part defects identification in selective laser melting via digital image processing of powder bed anomalies

Abstract

Keywords Selective laser melting · Digital image processing · Defect detection · Powder bed · In situ monitoring

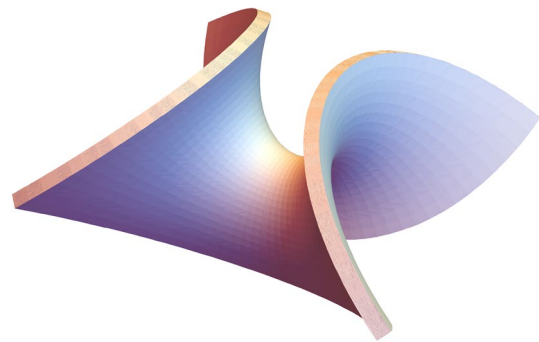
Fig. 6 Surface defects on Enneper surface printed via SLM

A particular geometry was selected to prove the capability of the method. It is a 3D representation of the well-known Enneper's minimal surface, namely a surface with zero mean curvature according to the Enneper Weierstrass parametrization [55]. After providing a thickening of the surface in accordance with [56], the STL shown in Fig. 6 was generated.

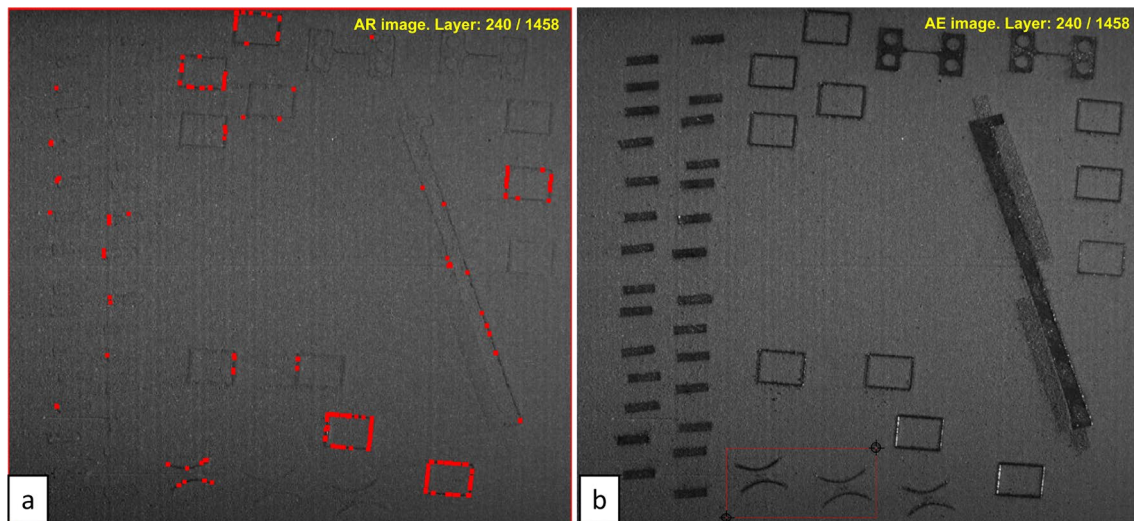
Fig. 7 AR image of build plate (a), selection of the region of interest (ROI) area (b)

Fig. 7b, was considered. It is relevant to notice that the component exposure strategy was modified to improve the surface quality: the adopted volumetric energy density caused local deformation of the scanned area, resulting in a lack of recoating, especially on the part contours (vertical and inclined and overhanging surfaces). Conversely, to the previous case, it is crucial to investigate the effect on the porosity caused by these issues above in the part under-skin. The AE 3D image is shown in Fig. 11a. This geometry is characterized by different slopes: 45° and -45° for inclined surfaces, 90° for vertical walls; and 0° for horizontal faces. Overhanging surfaces, namely those at a -45° , are supposed to have most of the defects as well as sharpened edges, which are subjected to residual stresses and deformations that may interact with the recoater. The powder bed around this component is densely characterized by anomalies, as pointed out by the 3D analysis reported in Fig. 11b. The defects on the part are mainly positioned on edges and overhanging surfaces (Fig. 11a).

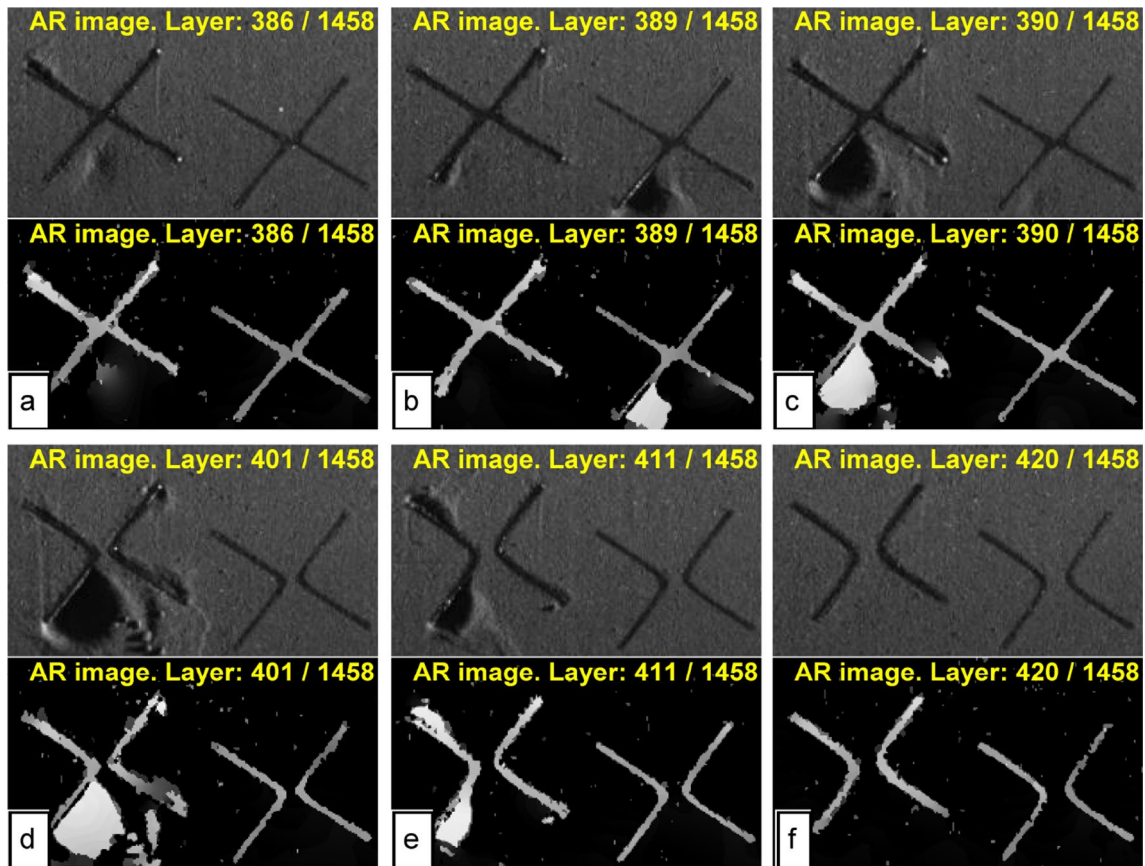
Fig. 8 ROI images of powder bed without flaws (**a**, **f**), damages on the first Enneper (**b**), propagated anomalies across layers (**c–e**)

By rolling the various layers, the powder bed of the selected area is well recoated, as shown in Fig. 8a, where the Perona-Malik and Gaussian filter are applied. At layer 386 (Fig. 8b), the second Enneper is affected by an anomaly which may cause a defect on the final part. At the next layer, shown in Fig. 8c, the previous flaw is recovered whilst a bigger void is now present on the first Enneper.

This second anomaly persists for several layers: after 11 layers (Fig. 8d) are grown, after 21 layers (Fig. 8e) are reduced until layer 420 is completely absorbed by the recoating operation (Fig. 8f). This analysis highlights that these

two anomalies are deeply different in volume. The height of the former is only one layer and can probably be neglected. The latter is characterized by a propagation across about 21 layers, leading to an anomaly height of about 0.6 mm.

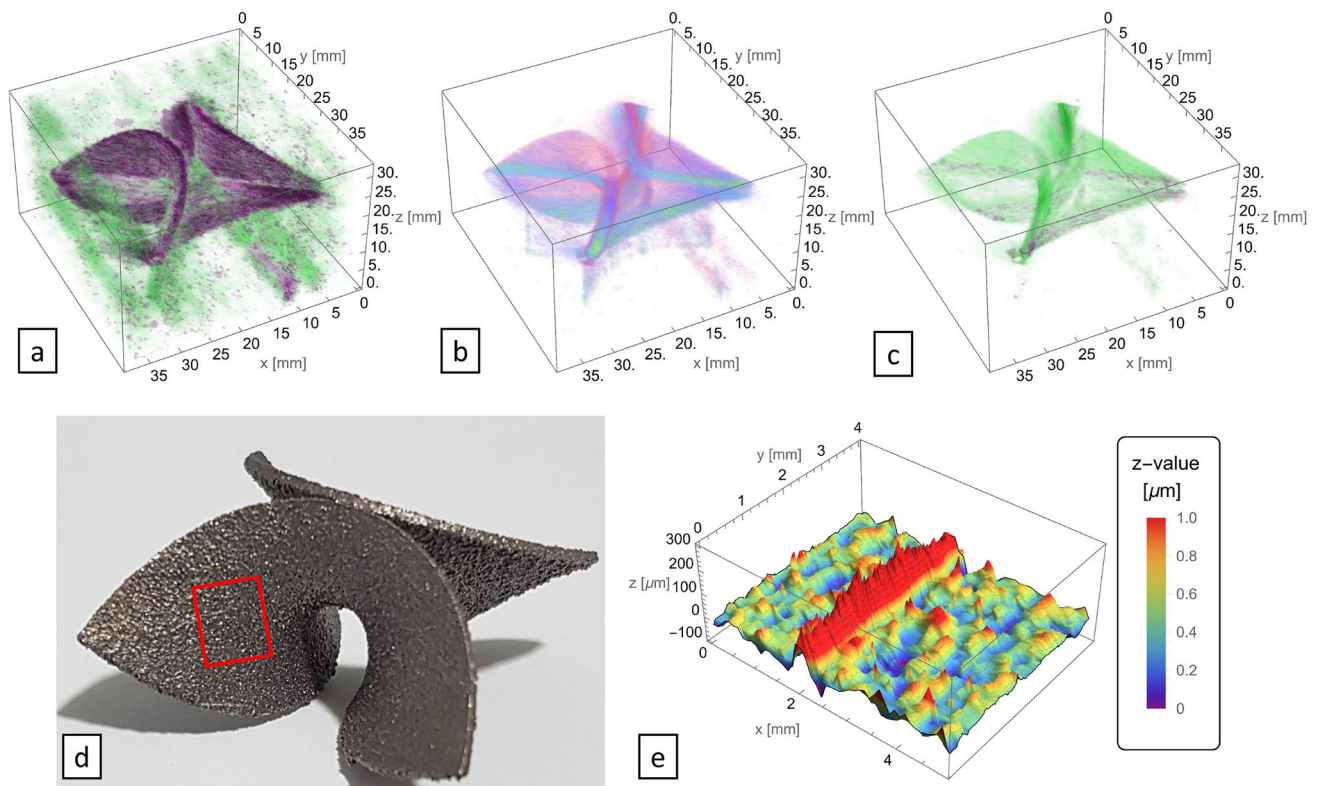
Fig. 9 3D images of the damaged Enneper, 3D images AR (a), 3D image AE (b), multiplication AR & AE (c), printed part (d), 3D map of highlighted zone (e)

3D analysis is a straightforward way of detecting anomalies inside the scanned area without manually understanding the propagation across layers. The previous Enneper parts were analyzed and compared. The filtered AR images were stacked into a 3D image, generating the result shown in Fig. 9a. The false colors highlight the different dimensions of the defects. This representation is interesting but confusing because many defects are positioned outside the scanned area. By applying the procedure for AE images where the powder bed defects are removed by 3D morphological operations, the scanned volume is reported in Fig. 9b. Since the powder bed lacks affect the laser consolidation, it is well evident that at around layer 400, the intensity of the color is different. By intersecting both the previous results, a 3D image of only the anomalies in the scanned area is obtained (Fig. 9c). The areas in the part affected by the anomalies are visible, and they have an extension in the stratification direction of 0.6 mm. By simply looking at the manufactured part, it is difficult to notice any problem on the surface (Fig. 9d) but by analysing the surface by means of a profilometric measurement, a flaw is detected. In Fig. 9e the 3D map of the surface highlights a line parallel to the y axes, which is parallel to the platform. This bump has a variable elevation ranging between 150 and 250 μm and a width of about 500 μm which is in accordance with the previous considerations. Elsewhere the surface is characterized by the common SLM behavior with a maximum peak-to-valley height of about 150 μm [57].

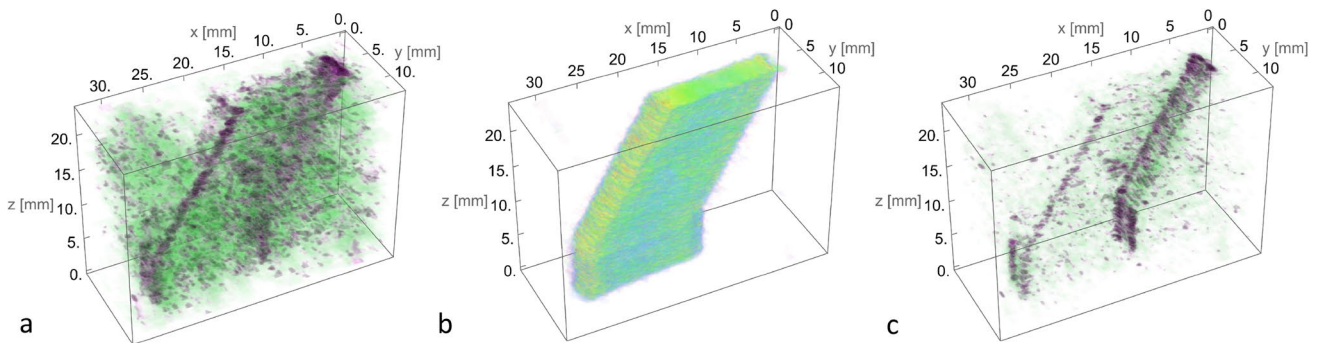
Fig. 11 3D Specimen (a), powder bed (b), and anomalies on part (c) 3D image
