An on-site teaching laboratory in a village damaged by the 2009 Abruzzo earthquake

ABSTRACT. This paper illustrates a two-year program of summer internships that involved forty students from the School of Engineering (University of Pisa) in 2010-2011. The activity consisted in a systematic survey of damages occurred in a village after the 2009 Abruzzo earthquake and in the preparation of documents addressed to a reconstruction plan. The historical center of San Pio delle Camere (1000 inhabitants) was fully surveyed, including about 140 hypogeal sites. Each student spent at least one month in these activities, funded by study grants provided by the Tuscany Region. Teams of two-three students performed well-defined work packages, led by a tutor, who established roles and functions. The students discussed the progress made preparing a weekly report. Moreover, preliminary structural analyses were carried out to assess the seismic vulnerability of some relevant buildings, fully available to the students. The main results were published in a book presented in a workshop. Most of the results were used to set up the official reconstruction plan of the village. During this on-site laborato

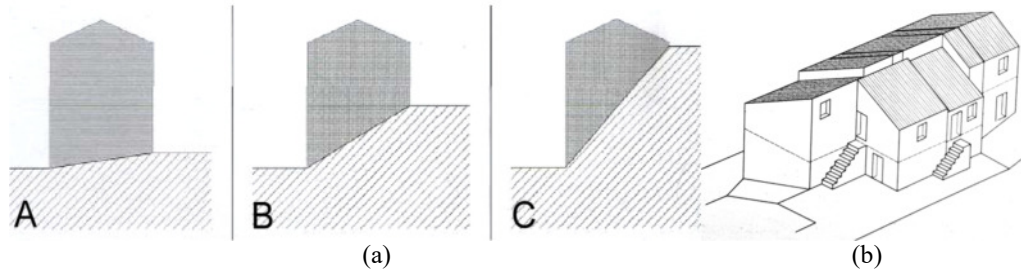
Figure 3: Buildings location in case of ground natural slope [1] (a); “Profferlo” house typical scheme [1](b).

During the night of April 6th, 2009, a main shock rated 5.9 on the Richter scale (M6.3) occurred in the Abruzzo Italian Region. This shock caused devastation, with 286 deaths and 1173 injured. San Pio delle Camere, 25 km far away from the epicenter, was made of 2-3 storey masonry buildings, built according to the schemes B-C of Figure 3a due to the sloping

ground condition. A considerable amount of houses in the city centre were of the so-called “Profferlo” type [1]: an external staircase and a multi-functional house (Figure 3b). The basement was often used for storage or as farm recovery, while the other floors were used for residential purposes. The newest part of the village, mainly made of r.c. buildings, was not damaged.

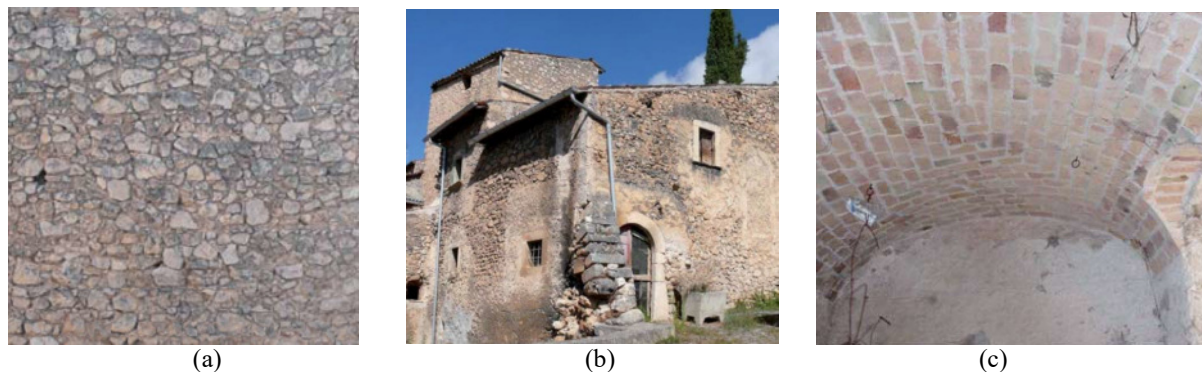
Figure 4: Old masonry texture (a); typical house in the city centre (b); masonry vault.

Masonry of poor quality was mainly made of small size stones with irregular shape (Figure 4a,b), without headers or transverse connections. Local mechanisms of out-of-plane rigid block modes and collapse of external leaves were detected [4]. Other relevant damages influenced heavy roofs in clay and r.c. diaphragms, besides flexible roofs such as vaults (Figure 4c). More extensive failures were surveyed in some buildings with hypogeal cavities, as illustrated in the next paragraphs. The buildings with masonry made of concrete blocks masonry, good quality mortar, steel ties and light timber roofs were less damaged.

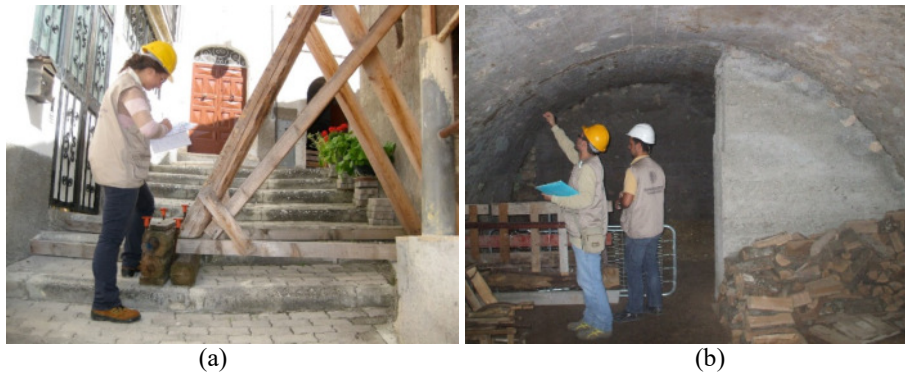
Figure 7: Students surveying structural features and damages of a building (a) and an hypogeal structure (b).

The students spent the first two-three weeks of the first campaign in a systematic survey of damages, most of them light or moderate cracks in masonry buildings of the historic center, as discussed in the previous paragraph (Figure 7). The main rehabilitation activities before and after the earthquake were also classified. The use of steel tie-rods, reinforced concrete plaster, curbs, metal beams was observed, but the effectiveness depended on the type of building, soil and construction in accordance with the best practices. They also made inspections in the newer part of the town, with r.c. buildings not significantly damaged, due to the lower soil amplification. The students could relate the damages of masonry buildings to their poor quality, both in terms of material and construction techniques [7]. Moreover, improper retrofitting techniques had been adopted before the earthquake, worsening a potentially dangerous building status. The students realized that (i) erroneous interventions could worsen a situation and that (ii) the use of simple anti-seismic devices, such as steel tie-rods on regular masonry (with regular units), could strongly improve the building response under dynamic actions. Indeed, the buildings with those elements showed less pronounced out-of-plane damage and performed much better without significant cracking. For what concerns point (i), it should be pointed out that the team tutors systematically explained why some interventions, e.g. the substitution of a timber diaphragms with an r.c. floor, could aggravate the building response in case of a seismic shock. In this way the building dynamic features could vary such a way that the overall structural stiffness increases and the seismic action is amplified.

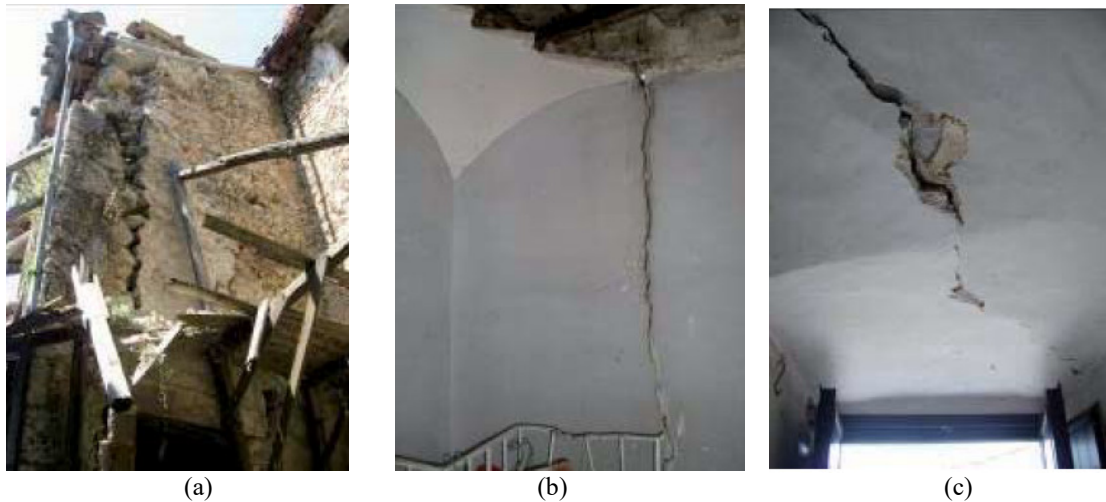
Figure 9: Masonry façade overturning (a); partial vault collapse (b); deep vault crack due to shear action (c).

Some historic buildings, such as the San Pietro Celestino Church, were declared unusable due to the collapse of the bell tower and an incipient overturning of the main façade. Other cases were also declared unusable for the external risk caused by adjacent buildings (Figure 9).

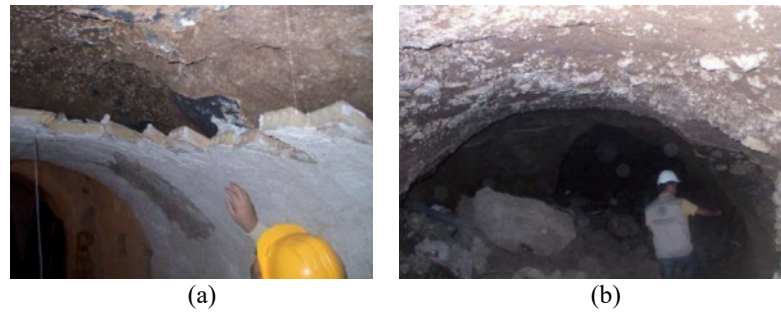
Figure 10: Qualitative survey of the hypogeal structures: assessment of the structural status (a); material and humidity level (b). The first team analysed the main structural characteristics of these chambers, such as the soil type and the humidity level (Figure 10a, b). Clay alluvium of red colour was mainly identified, with discrete cohesion and compact. Due to the lack of instrumentation, the survey was performed in qualitative but systematic way, which is sufficient for general information. The students could associate the chamber qualitative features to their structural behaviour: their stability is due to some low tensile material strength and plastic behaviour.

San Pio delle Camere is characterised by horizontal underground hypogeal structures (caves with chambers) (*Camere*, in Italian, Figure 3) excavated under the buildings in the rock or in the sedimentary alluvium. This structural feature was very interesting to be considered by the students, which had the possibility of understanding its role on the structural behaviour of whole building blocks. In particular, two teams of students systematically classified over 150 hypogeal structures (Figure 10), identifying three main typologies of chambers:

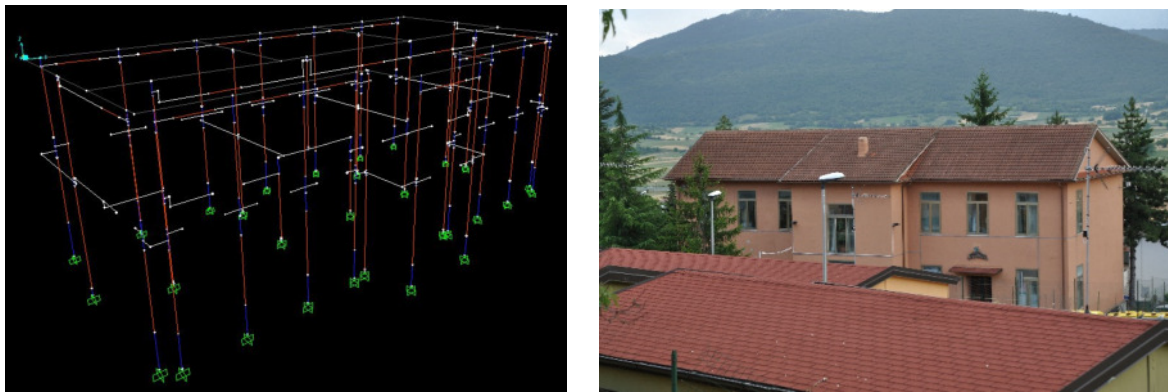
Figure 14: Case study of a municipality building: finite element model of a frame structure (a); actual building (b).

The last step of the campaign, performed by three student teams, was the structural analysis of selected case studies, such as schools and other strategic buildings. Simple linear dynamic analyses with computer-based programs were carried out (Figure 14). For this purpose, the students dealt with the computation of the response spectra corresponding to the main seismic shock record. Moreover, the computed spectra were compared to that provided by the Italian Standards, confirming

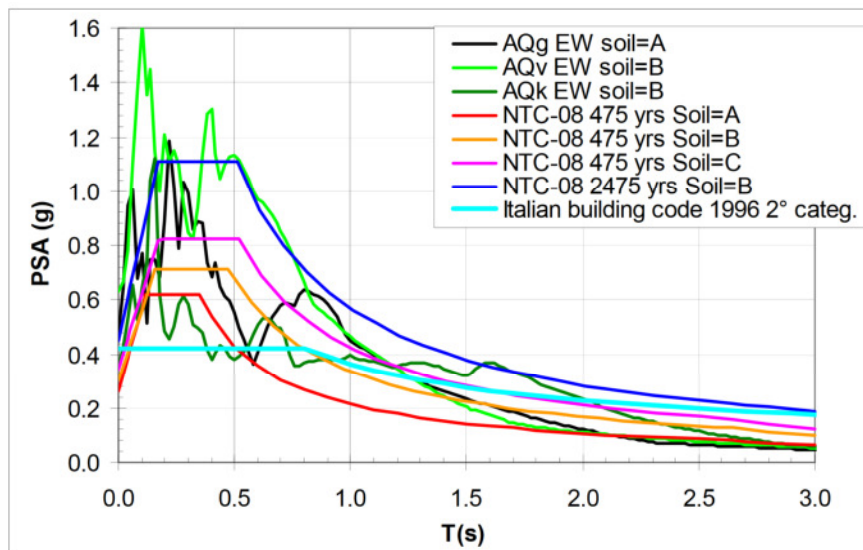
Figure 15: Comparison of the response spectra obtained by the seismic records (accelerometric station AQ=L'Aquila) with the response spectrum provided by the Italian Standards [22].

the results available in the literature [22] (Figure 15) and the students verified that the spectrum given by the codes was underestimated. In this manner, they had an opportunity to directly apply their knowledge related to seismic analysis (similar to the real professional practice), and also gain a deeper perception of the issue of analyzing real structures through physical models.

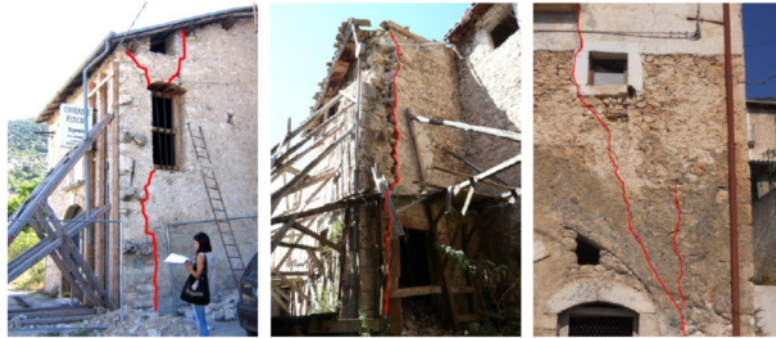
Figure 16: Observed building damage mechanisms, San Pio delle Camere.

Another activity consisted in performing kinematic analyses of several buildings damaged by the earthquake using the methods described in [14]. Firstly, the structural units were identified and the crack patterns with the activated damage mechanisms were detected (Figure 16). The more evident damage mechanisms were afterwards analysed to obtain the actual peak ground acceleration (PGA) which was recorded during the earthquake. The methodology concerned the application of simple kinematics of rocking block models, taking into account the horizontal inertial forces and the stabilizing effects of the self-weight and of any tie rods [15-19]. In some cases, the kinematics was applied to thrusting arches and vaults, with the results later used for research purposes [20-21].
