# Urban Transport XXIII

# MANAGEMENT OF SIDEWALK MAINTENANCE TO IMPROVE WALKING COMFORT FOR SENIOR CITIZENS

MARIA VITTORIA CORAZZA, PAOLA DI MASCIO & LAURA MORETTI

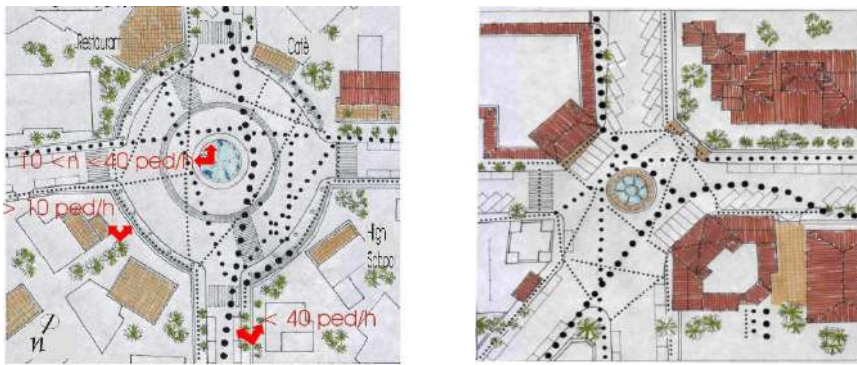
Figure 2: Pedestrians routes at two squares in the study area [9].

Although some functions and businesses changed in the surveyed areas in the last decade (a high school closed permanently in one square, a redesign program was carried out in the other, with sidewalks slightly broadened, and a number of new supermarkets opened nearby both), a recent survey confirmed the habits and the features already observed. Sidewalks maintenance was still poor and due to the same problems, pedestrians still favoured carriageways instead of sidewalks, traffic and pedestrian flows did not markedly change, drivers were still compliant with the speed limits. An element of variation was the increased amount of elderly pedestrians, especially in the morning hours. For this specific category, recurring activities observed were walking with shopping trolleys (35% of the surveyed flows) and pets (25%) and strolling (30%). Needless to say, the majority of them (around 65%) performed such duties jaywalking, detouring from sidewalks or walking directly on the carriageways. Some recurring habits were also observed among the “great elderly” pedestrians: they walk preferably on the sunny side of the streets (the survey took place on average working days in wintertime, and probably the shadowed side would be favored in summertime); when carrying shopping bags or walking pets, they tend to avoid areas perceived as too narrow or crowded (due to furniture, trees, etc.), even when actually there is plenty of room; once left the sidewalk for any of the reason above mentioned, they continue to walk on the carriageways until they have to cross again the street. Often, they stop on the carriageway to talk or rest and then resume walking.

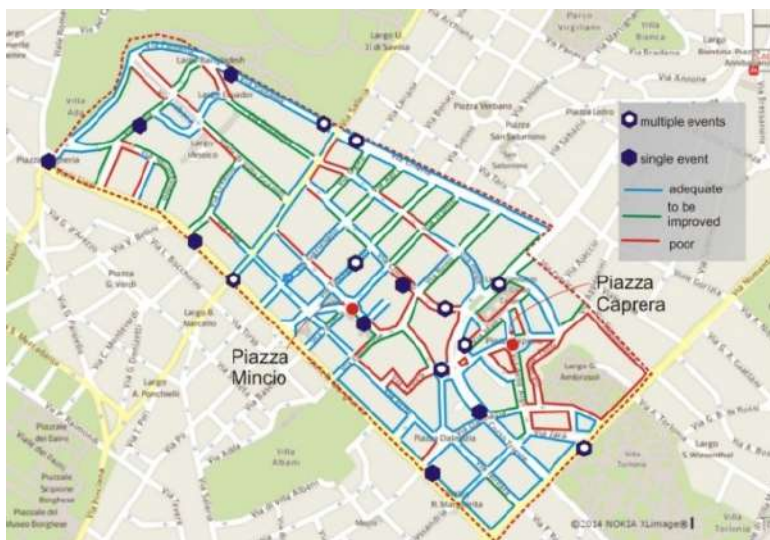
Figure 3: The TTF.

At the end of this process one area resulted more appropriate than the others due to the additional higher recurrence of accidents involving elderly pedestrians (Fig. 3). In this 5500 m<sup>2</sup> area, called the Trieste Test Field (TTF), the whole pedestrian pavements network was analysed, with exclusion of the private access areas, where sidewalks are interrupted (for example by driveways), as further described.
