# Design upgrade for the hybrid glulam-steel roof structure of the sports hall for the new High School in Gračanica

**Abstract.** This paper presents the design upgrade of the roof structure for a sports hall which consists of coupled glulam beams with steel substructure. The initial design has foreseen main glulam beams which are coupled with steel trusses and strengthened with rigid steel bars over the entire length. Due to some construction issues and design misinterpretation, the as-built structure did not follow completely the design and reinforcement rebars have been used instead of steel bars intended to be acting as steel ties. A design upgrade was required to preserve the main structure of the roof established with glulam beams, purlins and all the necessary layers to create a flat roof deck for students' access. The main challenge of the new design was to preserve the glulam beams and the initial architecture for the roof structure while ensuring safety for both the ultimate and serviceability loading cases. Initially, four proposals are provided with different solutions and among them only two are chosen for the further assessment based on safety, cost estimation, feasi

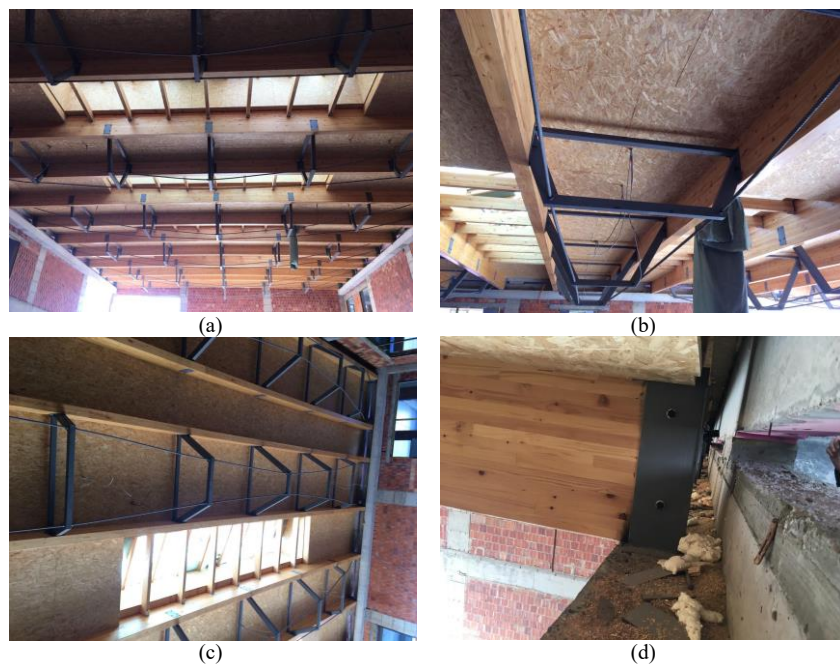
The coupled beams of the sports hall conceptually present a spatial problem of the typical hybrid glulam-steel structure, where the glulam timber beams resist compression and the deviated steel structure (steel rod or tie) resists tension. The as-built situation of the roof is shown in Fig. 1, where seen from below in (a) can be observed the glulam-steel coupled beams and in (b) and (c) can be noted the reinforcement not resisting any force and misaligned. Another concerning issue was noted in Fig. 1 (d), where due to the insufficiency of the supporting length crushing of the glulam timber beam could occur due to increase in stresses normal to fibers.

**Fig. 1.** As-built structure of the roof.

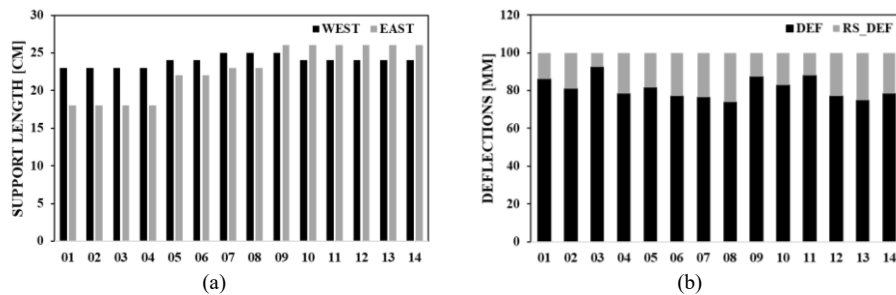
After a topographical survey on site, actual deflections from the self-weight and the supporting length of the beams were recorded, shown in Fig. 2. The glulam beams before placements are pre-cambered with 10 cm and that is why the deflection in Fig. 2 (b) is shown relevant to this uplift. Another important issue was regarding the strength class of the glulam beams and the structural steel provided for the roof structure. The material strength class of the as-designed glulam beams and steel was GL36h and S300, respectively, whereas the as-built structure comprises GL24h and S235 for the glulam beams and structural steel, respectively.

Fig. 2. On site measurements of (a) support length and (b) deflections.

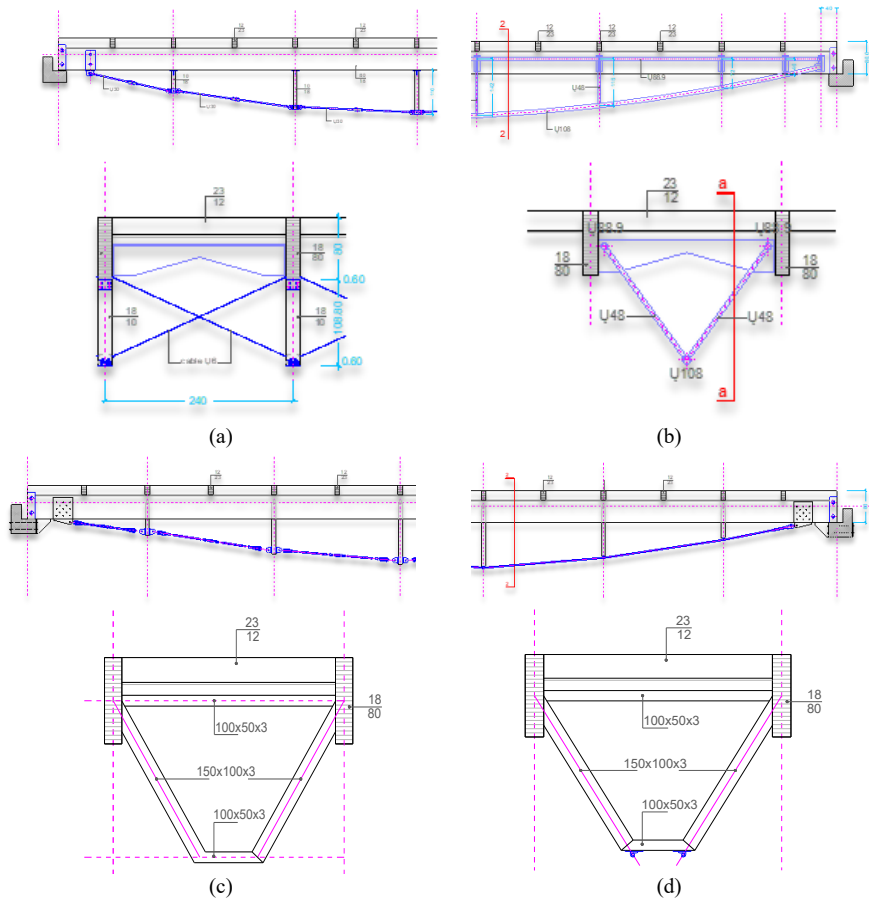
Following all the available information and details from the as-built and the details of the previous design, 4 proposals were given for the solution of the problem on site, shown in Fig. 3. In (a) is proposed a linear truss which is composed of the typical upper glulam beam and a deviated steel tie underneath to accommodate the tensile forces arising from the significant bending moment. In contrast, in (b) is proposed a space truss by replacing all the existing steel frames and in (c) is given a solution to replace only the reinforcement rebars with steel rods connected at each intersecting joint. Finally in (d), is proposed to replace the reinforcement rebars with a steel cable which is anchored at both ends and is tensioned to undertake the forces. Since the two first proposals in (a) and (b) are not in compliance with the constraint to preserve the architecture, they are not considered at all leaving only the ones in (c) and (d) for further detailed assessment.

**Fig. 3.** Proposals for the redesign of the roof structure: (a) Proposal 1 – Linear Steel Rods, (b) Proposal 2 – Space Steel Truss, (c) Proposal 3 – Space Steel Rods, (d) Space Steel Cables.

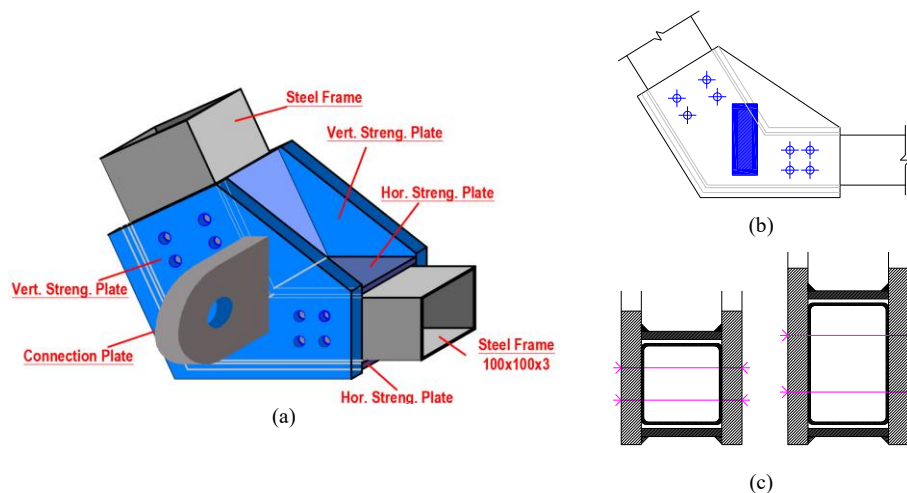
Globally the structural issues on the roof are easily solved and also construction imperfections can be neglected on the overall behavior. Complexity and concern arises on the micro assessment of the joint connection for the steel rods which have to be installed on site and on an existing structure that cannot be dismantled. It is impossible to avoid misalignments and deviation of axis in all three dimensions for the joint connections of the rods. Adding the construction implications and site conditions this becomes an enormous problem. As it was mentioned earlier the steel frames coupling the glulam beams are made of 3 mm thick profiles and as such present an issue when it comes to transmitting huge amount of forces and therefore stresses and strains. Several trials were conducted, which also involved a lot of proposals to strengthen the joint and achieve compliance with the codes, but the cheapest and the easiest solution in means of construction is the one shown in Fig. 4.

Fig. 4. Axonometric view (a), Front view (b) and cross-section (c) of the strengthened joint.

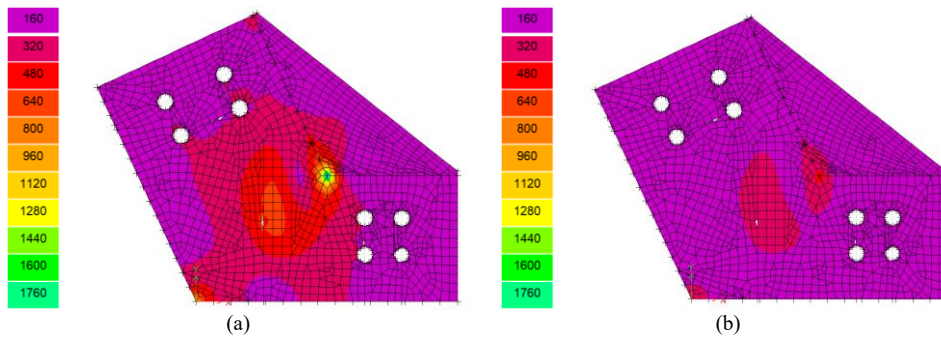
Numerical stress analysis of the joint included a lot of factors to be taken into account which yielded in a numerous advanced steel plastic analysis that are out of the scope of this paper. Nonetheless, the final most important analysis included the stress and strain check of the vertical strengthening plates (refer to Fig. 4). Since localized stresses rise from the connection plate, it is impossible to achieve verification inside the yield domain of steel (elastic domain) so the structural check is achieved in the plastic domain which is verified according to the provisions given in [8]. These provisions allow stress redistribution and limit the plastic strains to a certain limit of  $\epsilon_{pl}=5\%$ . The Von Mises stresses after redistribution (a) and the plastic strains (b) are shown in Fig. 5. It must be noted that the results are shown in a limited range of values where the minimal Von Mises stress shown is the maximum yield stress and as such everything lower than this is lost in graphical representation since it is not of interest. Similarly is done with the corresponding strains.

**Fig. 5.** Von Mises stresses in MPa (a) and Von Mises strains in % (b).

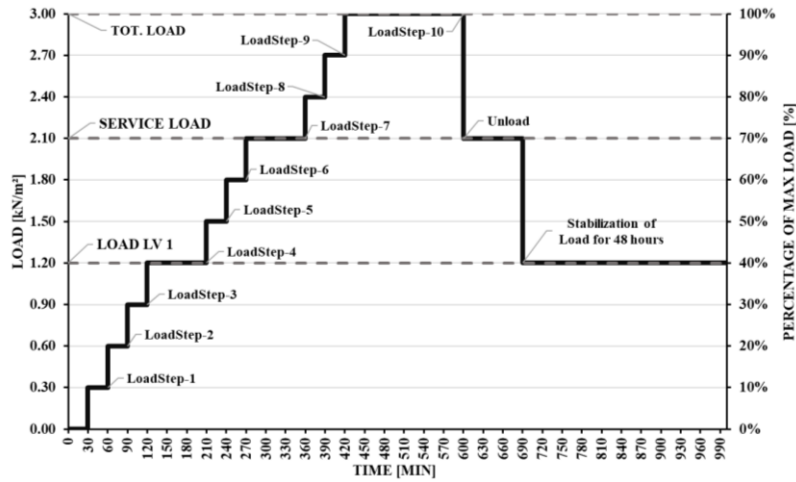
Instead of conclusions, in order to ensure the safety and the functionality of the proposed solution for the structure a loading test is required and hereby presented. In this case the terms of reference for the tests are prepared following several guidelines [9, 10, 11], in absence of specific timber norms for loading tests, under which they shall be conducted to ensure proper assessment of the structure. The testing shall be conducted using a water pool on top of the most solicited coupled beams according to design, as it is easier to fill, drain and control the load level on the roof. Loading and unloading for the test shall follow a protocol (Fig. 6) under which are given the provisions of performance. The maximum load of  $3.00 \text{ kN/m}^2$  corresponds to 30 cm of water in the water pool.

Fig. 6. Loading Test Protocol.

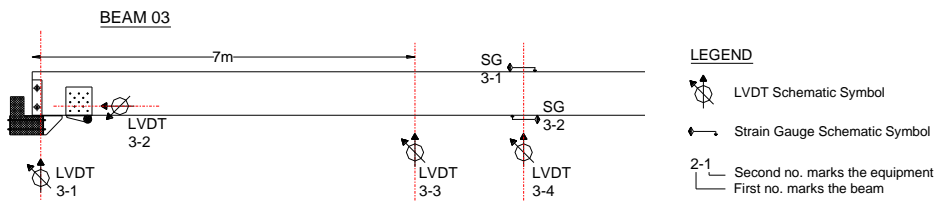
To capture all the necessary measurements a scheme for the location of the equipment is given in Fig. 7. LVDTs and strain gauges are required in such a way as to correlate results obtained in different directions and if taken directly may lead to mistakes.

Fig. 7. Schematic localization of LVDTs and Strain gauges for the beams.

Methodology requires the measurement of the maximum deflection of the beams under the maximum load and then after the stabilization of loads for around 48 hours, residual deflections are measured. Comparing the two deflections provides the acceptance criteria and the level of safety for the structure. While residual deflections ( $\Delta_{res,max}$ ) are less than 25% of the total maximum deflection ( $\delta_{max,100}$ ), this criteria is achieved and the structure is safe concerning the service loads.
